## Identifying the opaque (black) dust produced by the shedding of galvanized coatings within HVAC systems

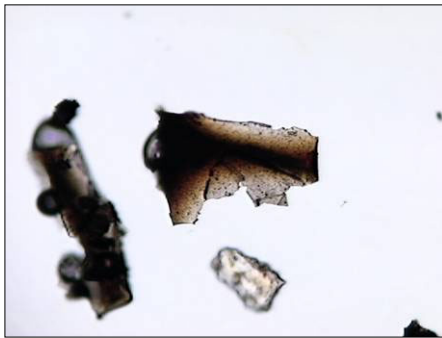
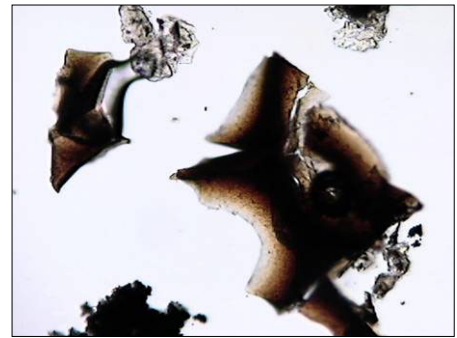
~200X

**Optical  
Microscopy**

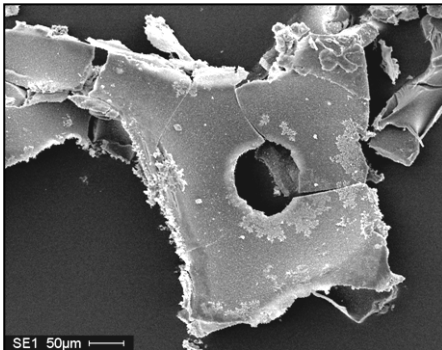
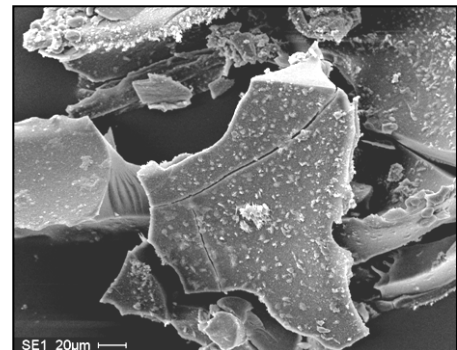
~200X

**Scanning  
Electron  
Microscopy**

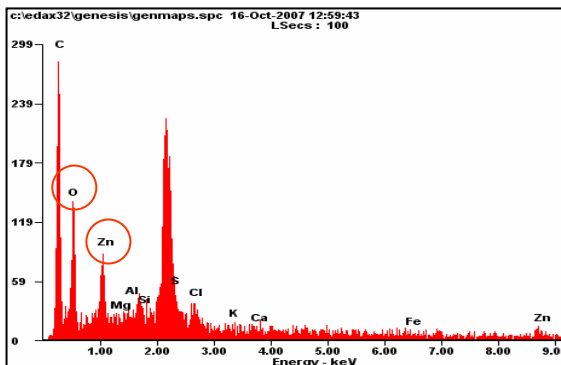
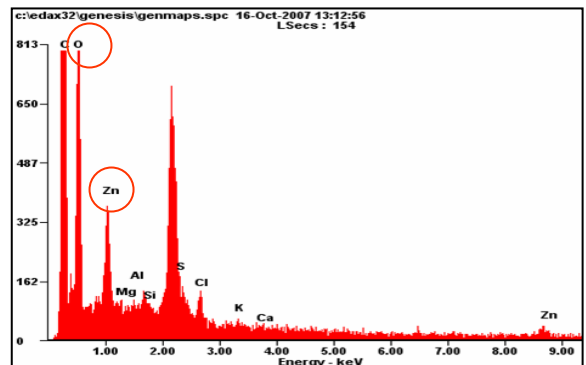
**Dispersive  
X-ray  
Analysis**
