Environmental Analysis Associates, Inc.

Identifying HVAC system component corrosion and abrasion particles in indoor air quality samples

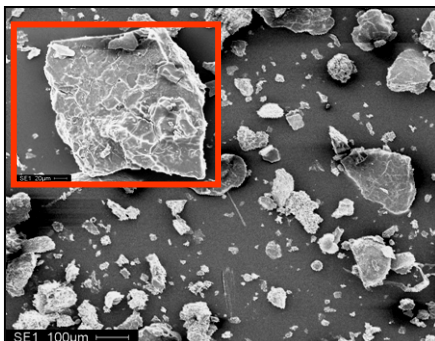
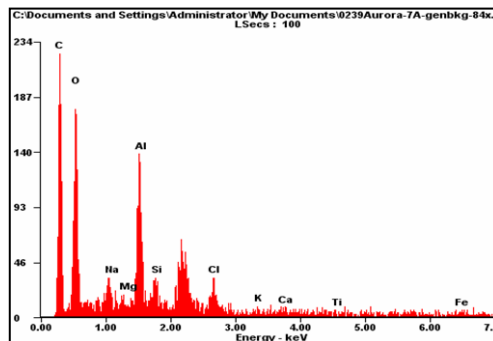
HVAC ducting corrosion :

Characteristic aluminum oxide particles derived from the oxidation and corrosion of metal ducting due to moisture exposure. (Note the presence of sodium & magnesium chloride salts)

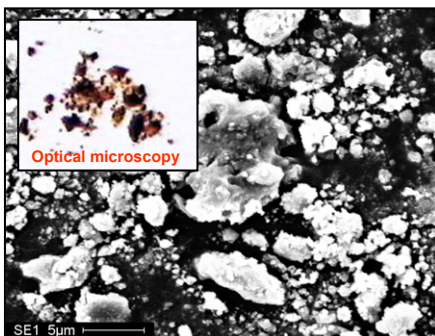
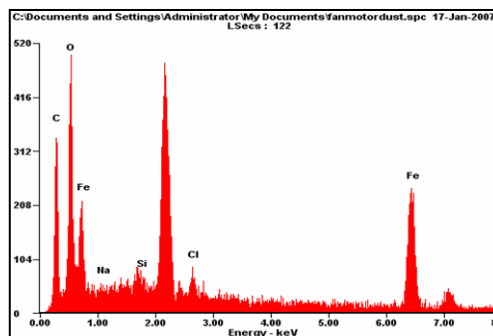
HVAC motor abrasion :

Characteristic iron oxide particles generated from the frictional abrasion of an HVAC fan motor. (Note the relative absence of sodium & magnesium chloride salts)

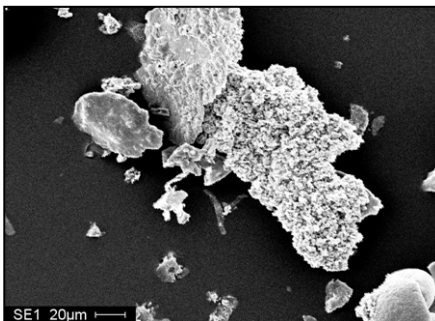
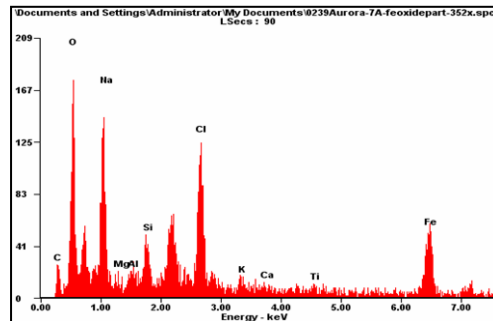
Metal component corrosion from exposure to water :

Characteristic iron metal corrosion particles derived from moisture exposure. (Note the abundance of sodium & magnesium chloride salts)
