Environmental Analysis Associates, Inc.

Identifying the fiberglass fibers and debris produced from the shedding of HVAC black soundliner insulation

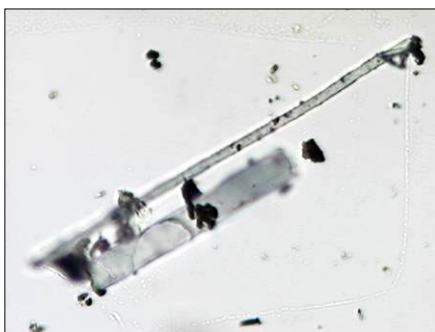
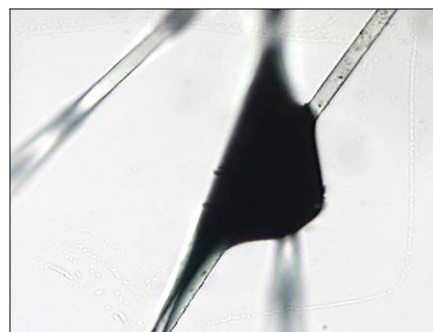
Example of fiberglass fibers associated with black soundliner insulation (Photo #1). Photo #2 shows intact black binder resin

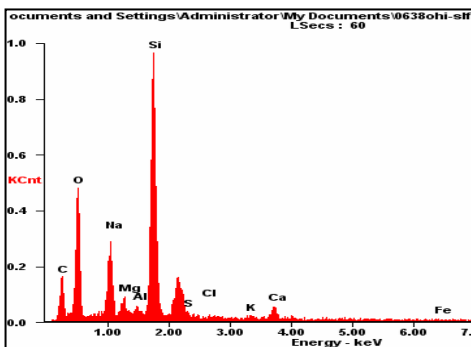
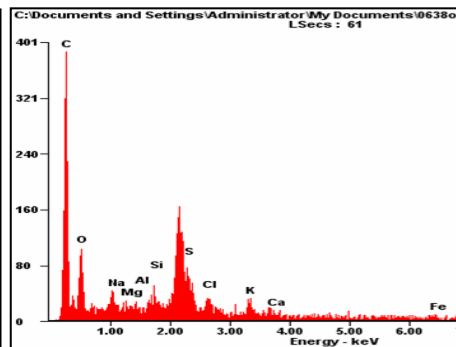
X-ray spectra of insulation and resin binder :

Spectra #1 is of the fiberglass fiber. The fiber is a low calcium / high sodium silicon dioxide glass.

Spectra #2 is of the black organic binder resin attached to the fiber

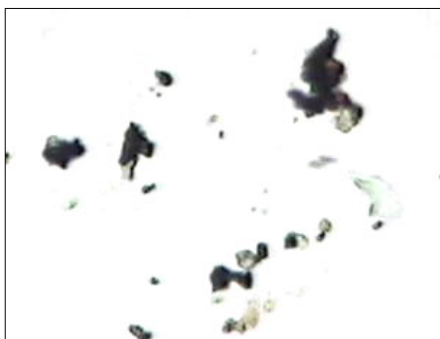
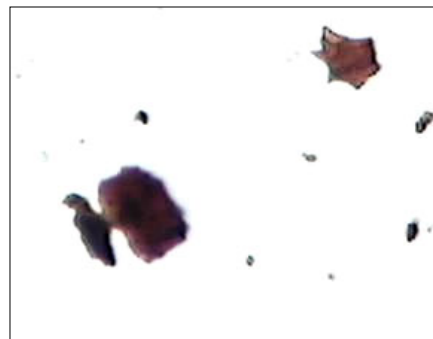
Resin binder dust

Examples of black and rust colored resin binder particles using optical microscopy (~1000x). Particles appear black with an irregular or plate-like morphology.

When the particles are thick, they appear black (opaque) and brown or rust colored when they are thin and plate-like.

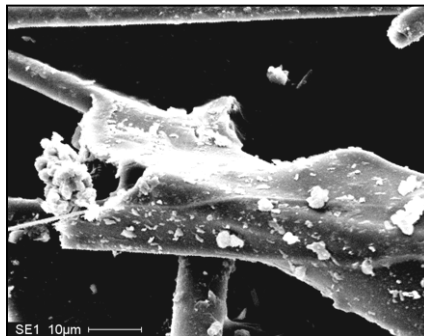
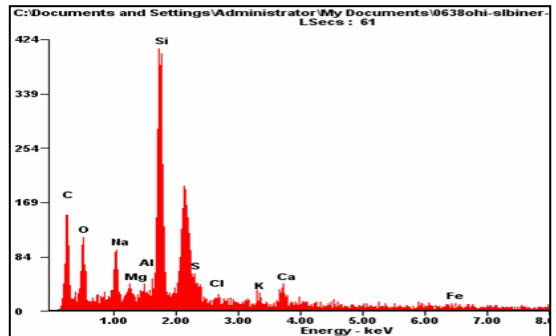
SEM photo 1440x

Mixed spectra of the fiberglass fiber and binder matrix

Examples of the variation in soundliner binder x-ray spectra when mixed with other particle debris

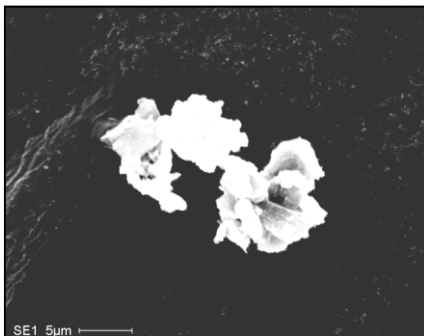
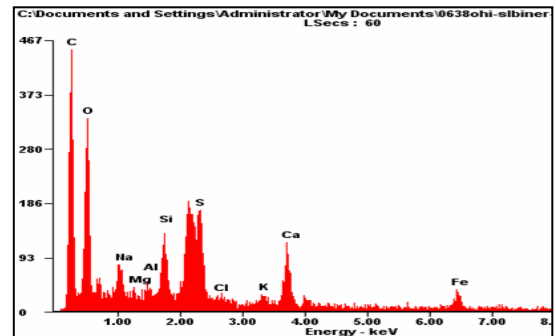
SEM photo 2890x

Particle binder agglomerate mixed with drywall dust. Note the presence of calcium, sulfur and iron.

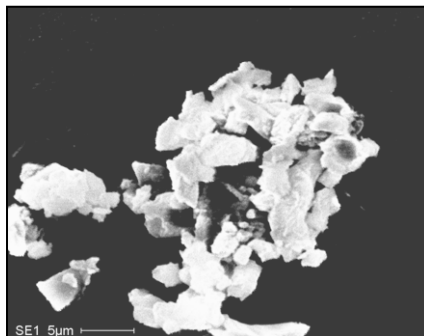
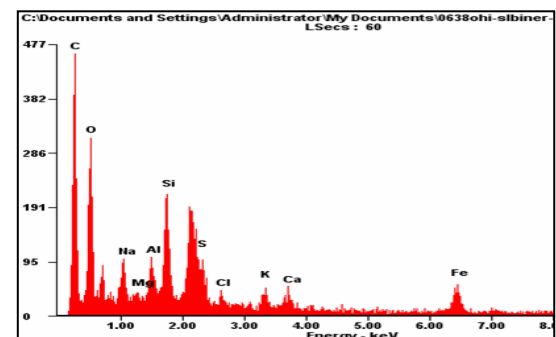
SEM photo 2890x

Particle binder agglomerate likely mixed with minor amounts of calcium, sulfur, and iron.

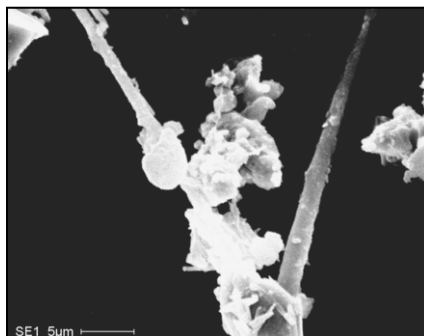
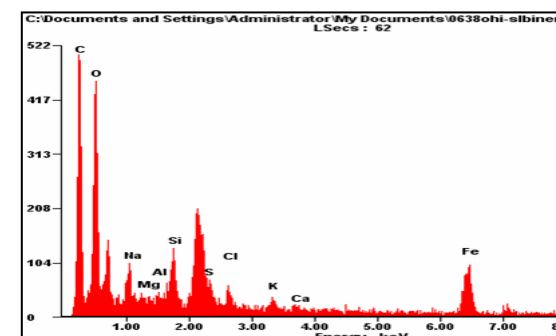
SEM photo 2890x

Particle binder agglomerate mixed with moderate concentrations of iron.
